RIVER AUX VASES BASIN
BUTTERFLY AND RAINBOW LAKES
STE. GENEVIEVE COUNTY, MISSOURI

MISSOURI INVENTORY NOS.
BUTTERFLY LAKE MO. 30501
RAINBOW LAKE MO. 30641

PHASE I INSPECTION REPORT
NATIONAL DAM SAFETY PROGRAM

SEPTEMBER 1978

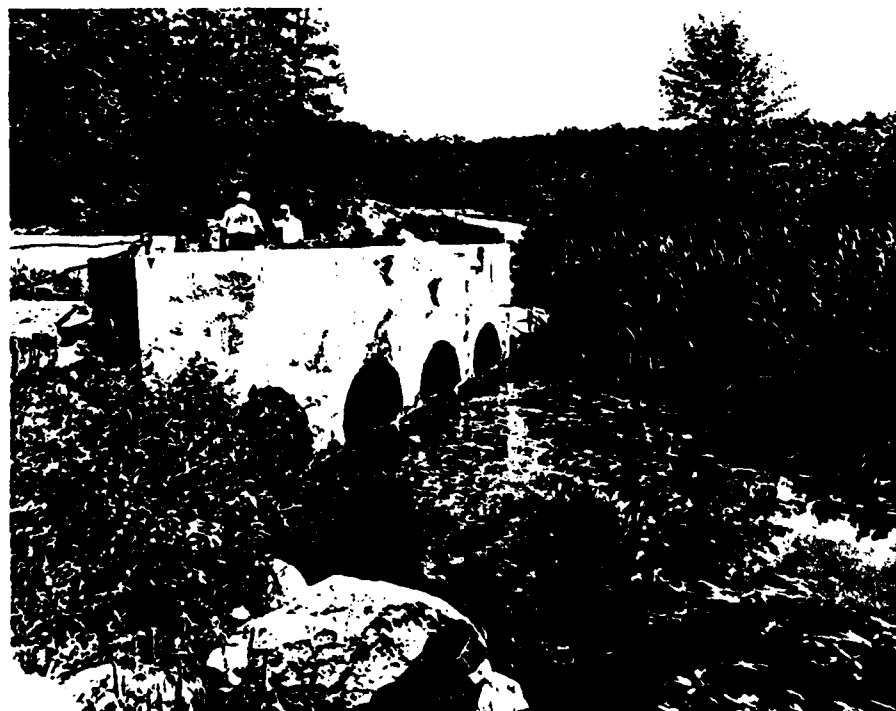
PHOTO 16 Rainbow Dam - Upstream Side
of Outlet
